OPERATING EXPERIENCE WEEKLY SUMMARY

Office of Nuclear and Facility Safety

September 3 - September 9, 1999

Summary 99-36

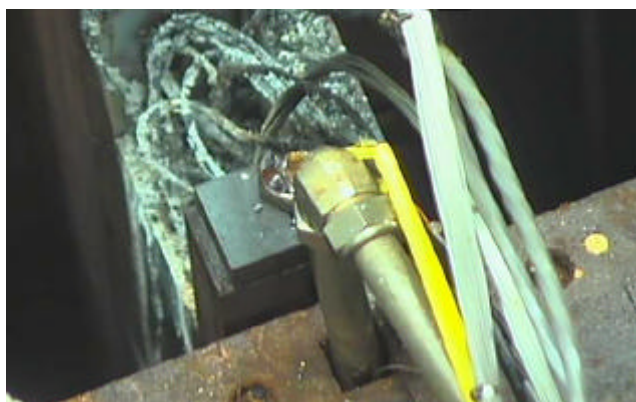
At the time of the incident, a LANSCE-7 technician had energized the radiant heaters for approximately 20 minutes before LANSCE and APT personnel arrived to receive operational training on the equipment. Upon arrival, an APT researcher noticed that the experimental data acquisition system was not operating so he turned it on to verify the temperatures indicated by the Allen-Bradley control system. Personnel immediately realized that some of the thermocouples were indicating room temperature while others mounted in the same position indicated temperatures as high as 330 degrees Celsius. The LANSCE technician immediately de-energized all of the heaters. Figure 3-1 shows the damaged wiring and insulation on the top of the steel insert (the damaged area measures approximately 6 inches from right to left).

Figure 3-1. Damaged Wires and Insulation

Investigators determined that the thermocouples for the steel insert were not connected to the Allen-Bradley control system. Instead, a technician had mistakenly wired thermocouples from another experimental system into the Allen-Bradley control system from a patch panel adjacent to the one containing the correct thermocouple connections. The thermocouples for the other two over-temperature trips were connected correctly. Investigators determined that although the power supply, the heater controller wiring, the heater face thermocouples, and the air gap thermocouples were verified through inspection and operational testing, the configuration of the installed thermocouples for the over-temperature protection of the steel insert was not. APT managers had identified the possibility of wiring errors in their hazard analysis for the actual beam use. In order to mitigate this hazard, they required that the wiring must be independently checked every time someone worked on it. However, the independent check was not done in

this case. They also determined that the equipment was energized and operating before APT researchers, who owned the equipment, were present and that the data acquisition system that provided thermocouple readings was not operating at the time the equipment was energized.

This event underscores the importance of verifying that installed configurations of experimental equipment are correct. Control circuits and trip circuits should be operationally verified to ensure that they are functioning properly. In this case, human error resulted in the incorrectly connected thermocouples. To reduce the potential for human error, managers should ensure that (1) tasks are controlled by procedure, (2) tasks are supported by accurate drawings or diagrams, (3) components or equipment are labeled properly, and (4) verification is performed that demonstrates that the task was performed correctly. This event also identified a lack of formality regarding the assembly, start-up, and transfer of the experiment because project personnel considered the decay heat research an "add-on" experiment. Existing procedures that had been followed during previous APT experiments were not followed for this experiment. Although personnel hazards and appropriate controls had been identified for this experiment, controls for equipment protection were not rigorously considered.

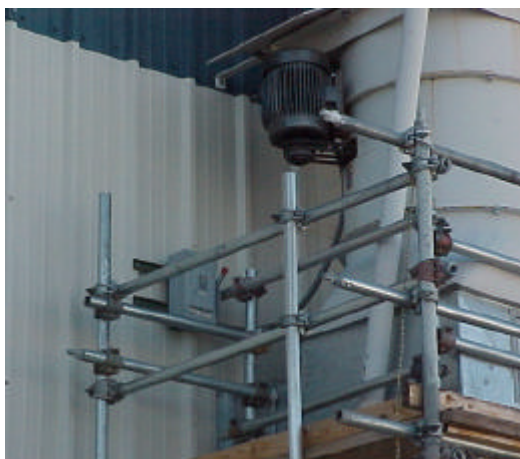
Investigators determined that when the electricians reviewed the work order before they accessed the scaffold to begin repairing electrical safety switches for ventilation system blower motors, they discovered that a previous work order step was not signed as completed. The electricians told the carpenter that he forgot to sign a previous work order step which required him to (1) contact safety personnel and obtain a safe work permit, (2) install a personal lock and tag on the fan motor, (3) adjust the scaffold railing, and (4) inspect the scaffold. However, the carpenter told the electricians that he had not performed the actions as defined in the work order step nor had he known that a work order had been issued for the job. Figure 7-1 shows the electrical box and the blower motor with the fan belt. Figure 7-2 shows an overall view of the scaffolding.

Figure 7-1. Electrical Box and Blower Motor with Fan Belt

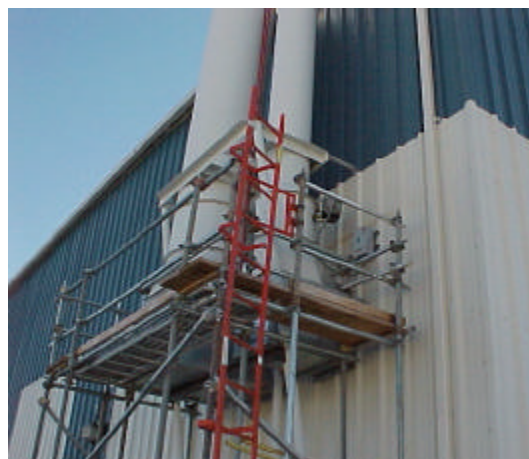
Figure 7-2. Scaffolding
